**Subject: Final Removal Assessment Report
Dymet Site
Muskegon, Muskegon County, Michigan
Technical Direction Document No. S05-0001-16-05-001
SRS Contract No. EP-S5-16-01**

**REMOVAL ASSESSMENT REPORT
DYMET SITE - RS
MUSKEGON, MUSKEGON COUNTY, MICHIGAN**

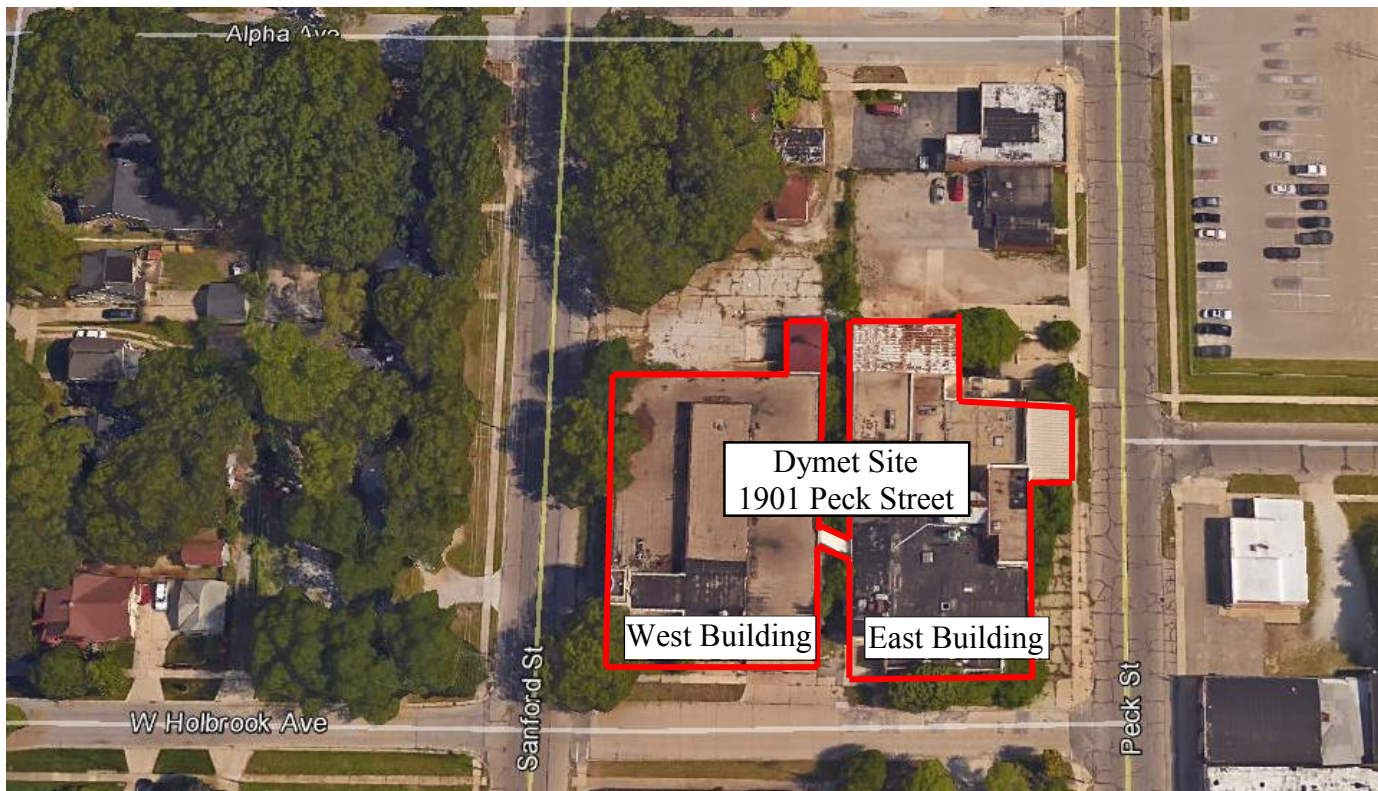
**FIGURE 2
SITE FEATURES MAP**

The Dymet Site is located at 1901 Peck Street, Muskegon, Michigan (Figure 1). The approximately 1.8-acre Site includes two buildings attached via an enclosed gangway. The buildings are secured by locked doors, however there are some broken and some boarded up windows. The Site is physically bounded to the south by Holbrook Avenue, to the east by Peck Street, and to the west by Sanford Street. Immediately to the north the Site is bounded by a radio station and a residential property, followed by Alpha Avenue. The Site area is a mix of residential, commercial, industrial, and recreational properties. There is a ballpark immediately across Peck Street, less than 0.1 miles to the east of the Site. Two large hospitals are located less than 0.3 miles to the north of the property and two public schools are located within a less than 0.5 miles to the north and west. According to a Michigan Department of Environmental Quality (MDEQ) report, the property has created a safety issue within the neighborhood through the evidence of graffiti and gang activity (MDEQ, 2016).

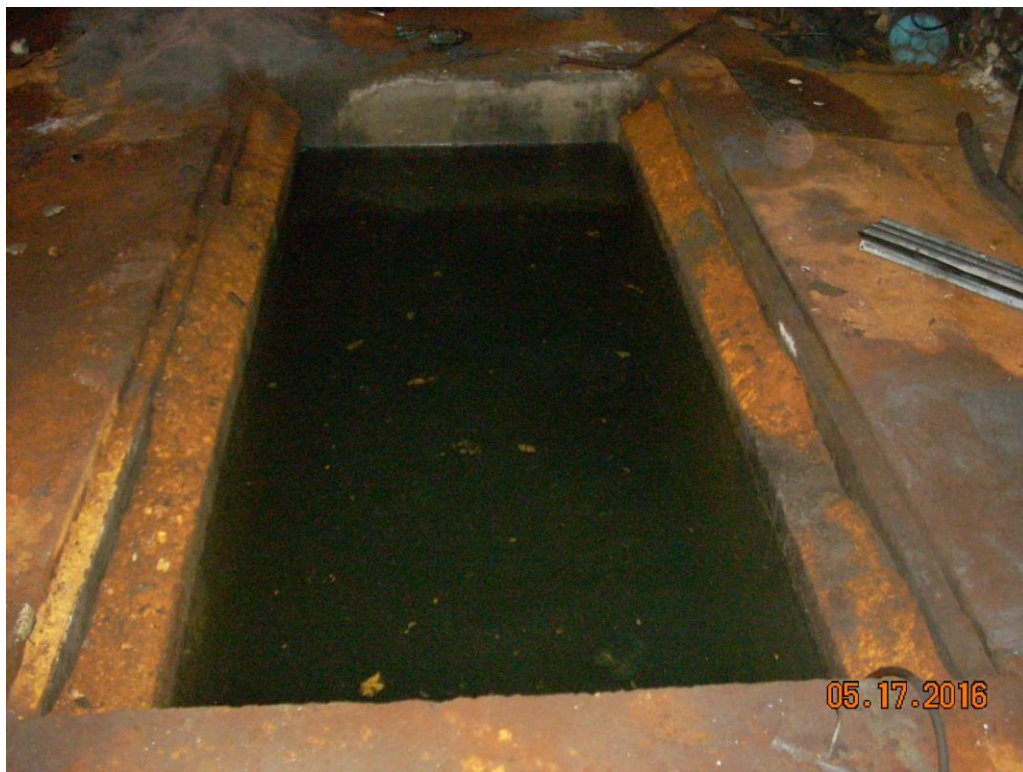
Photograph No.: 8
Floor pit

Four floor pits were observed in the east building. Two floor pits appeared to contain water while the two other floor pits appeared to contain a dark oily liquid. One floor pit containing the dark oily liquid was cordoned off by a yellow caution tape tied around drums. This floor pit was below a large piece of equipment (see photograph 10). The liquid observed in this floor pit was approximately five feet below the ground surface. The second floor pit containing a dark oily liquid was partially blocked by a yellow rail (see photograph 12). This floor pit was also below a piece of equipment. The liquid observed in this floor pit was approximately six inches below the ground surface.

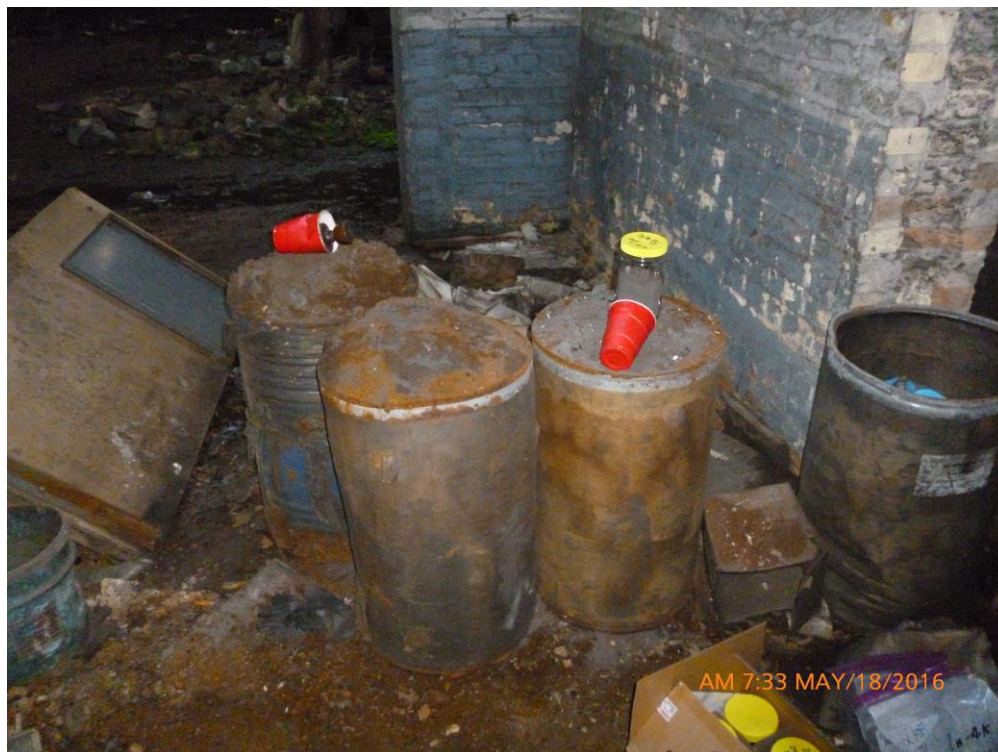
Photograph No.: 14

Spilled solids and drums containing solid material were observed in several locations throughout the facility. Several drums and containers were observed without lids and contained unknown solids (see photograph 14). Solids were also observed in piles on the floor in various areas of the east building (see photograph 16 and 18). In one area of the east building, a pile of white powder was observed spilled near a drum labeled “283LF Infiltrant” (see photograph 19).

Solids container from which
sample DYM-SOL-03 was
collected.

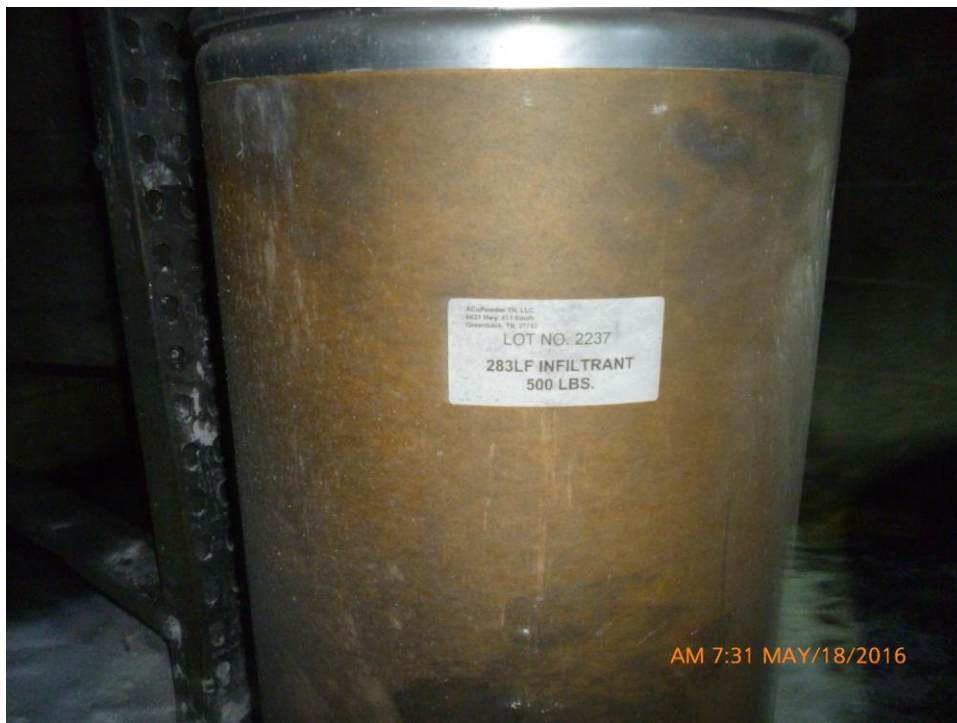
Photograph No.: 19

Labeled container on top of
floor solids from which
sample DYM-SOL-07 was
collected.

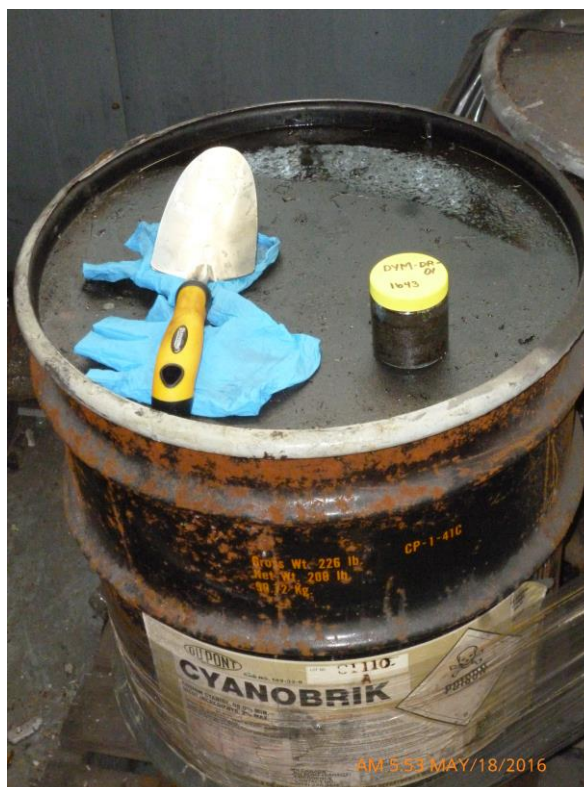
Photograph No.: 22

of ignitability, reactivity, corrosivity, and toxicity (DYM-DR-01, DYM-DR-02, and DYM-SC-03) were collected from rusted drums or containers (see photograph 21-26). These drums could continue to rust and potentially release hazardous characteristic materials and/or related gases.

Sample DYM-DR-01
collected from drum labeled
Cyanobrik - Sodium
Cyanide located in the west
building.

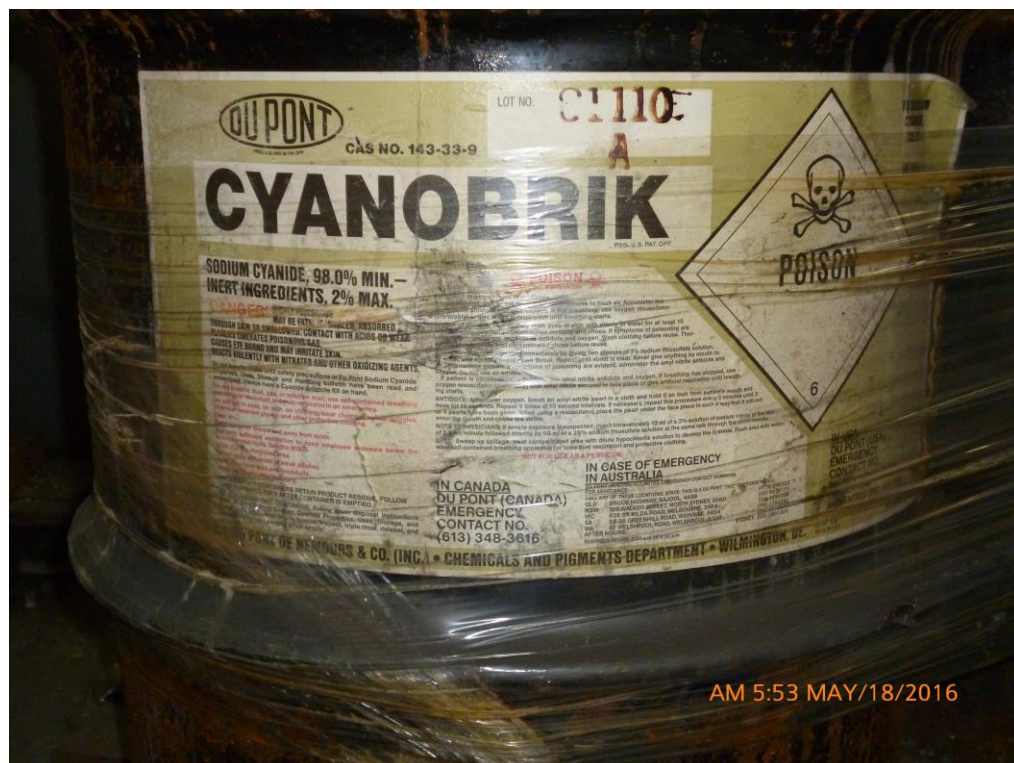
The drum labeled "Sodium Cyanide" from which sample DYM-DR-01 was collected, was located in the same room as the "Oxidizer" drum from which sample DYM-DR-02 was collected. Sample results from sample DYM-DR-02 indicated a pH less than 2 SU. Both the "Sodium Cyanide" and the "Oxidizer" labeled drums were beginning to show signs of deterioration, such as rust.

Photograph No.: 23
Drum labeled Sodium
Cyanide, 98.0% min.,
Poison from which sample
DYM-DR-01 was collected.

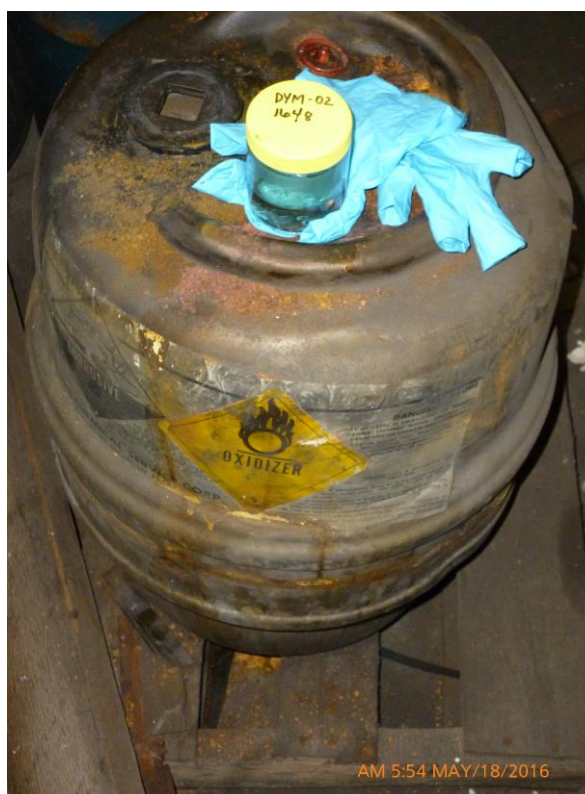
Liquid drum sample DYM-DR-02 was collected from a drum labeled “Oxidizer” and “Corrosive” using a dedicated glass drum thief (see photographs 24-26). The liquid was clear

in color. The drum from which the sample was collected showed signs of deterioration. The liquid drum sample was analyzed for corrosivity determination by pH in accordance with EPA Method E150.1.

Photograph No.: 24
Sample DYM-DR-02
collected from drum labeled
Oxidizer.

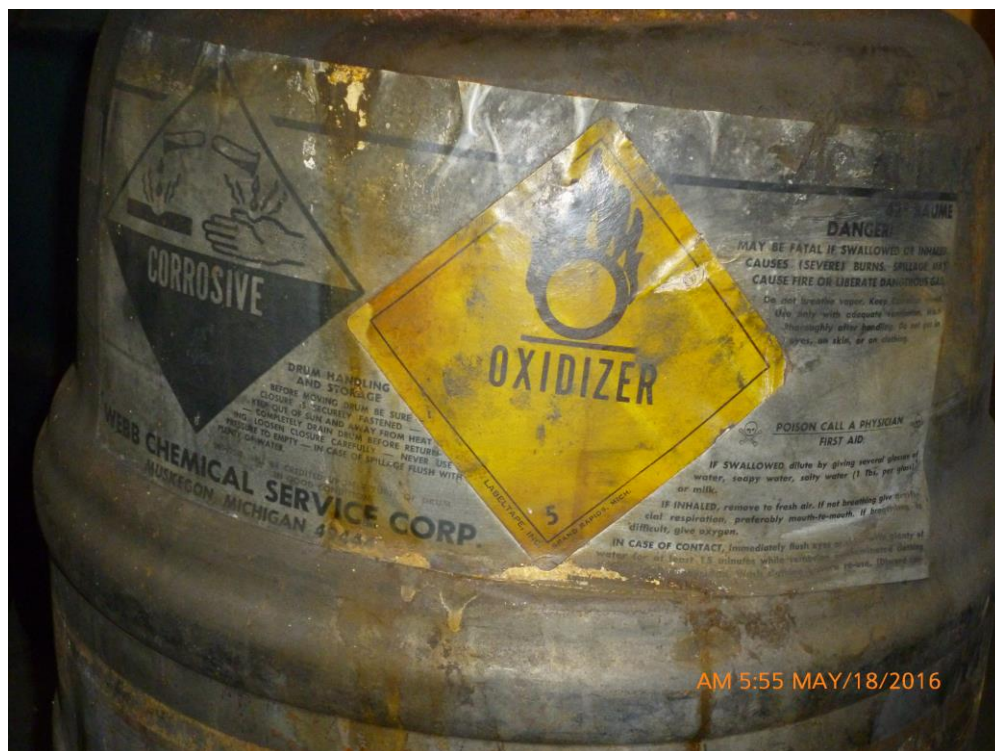
Photograph No.: 25

Drum labeled Corrosive and
Oxidizer from which
sample DYM-DR-02 was
collected.

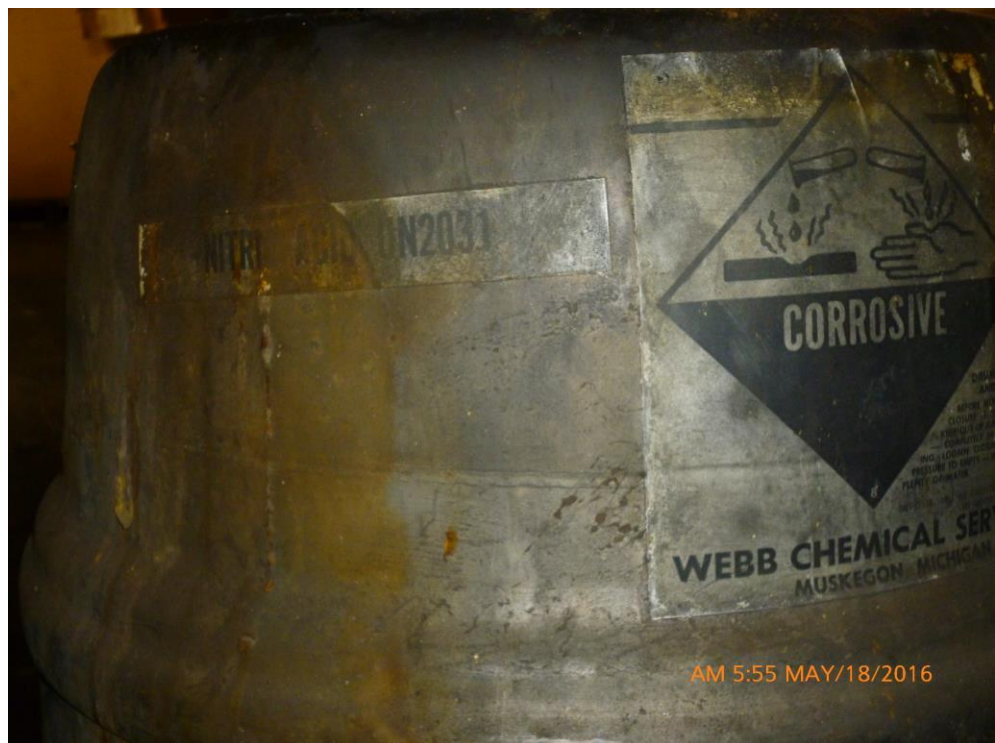
Photograph No.: 26

Oxidizer drum labeled
Nitric Acid from which
sample DYM-DR-02 was
collected.

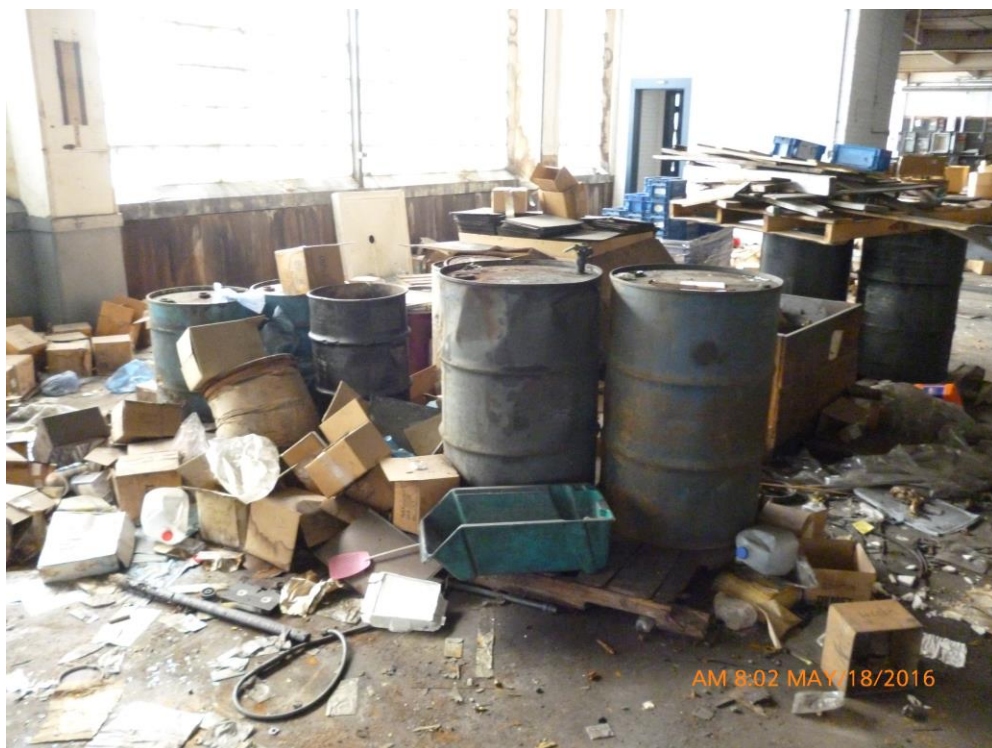
Photograph No.: 34

Drums and containers were present inside both buildings. Drums were observed staged in groups of three to fifteen (see photographs 34-36) and contained varied amounts of material at the time of site reconnaissance. Drums labeled “Sodium Cyanide- Poison” and “Oxidizer” were observed in the main room of the west building near a staging area of numerous other drums. Two 55-gallon sodium cyanide steel drums were wrapped in plastic wrap which covered the label. The two drums were rusted and exhibited signs of deterioration. The 35-gallon oxidizer steel drum also exhibited signs of deterioration.

Typical drum staging area
in the west building at the
Site. This area has
approximately 9 drums.

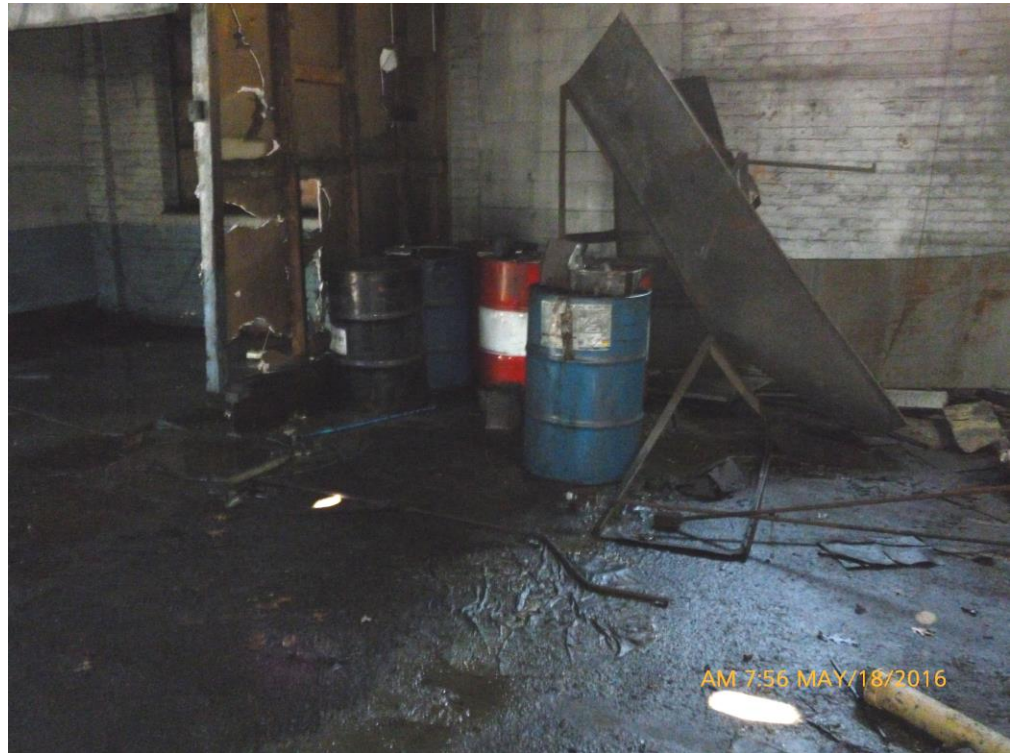
Photograph No.: 35

Typical drum staging area
at the Site. This area has
approximately 6 drums.

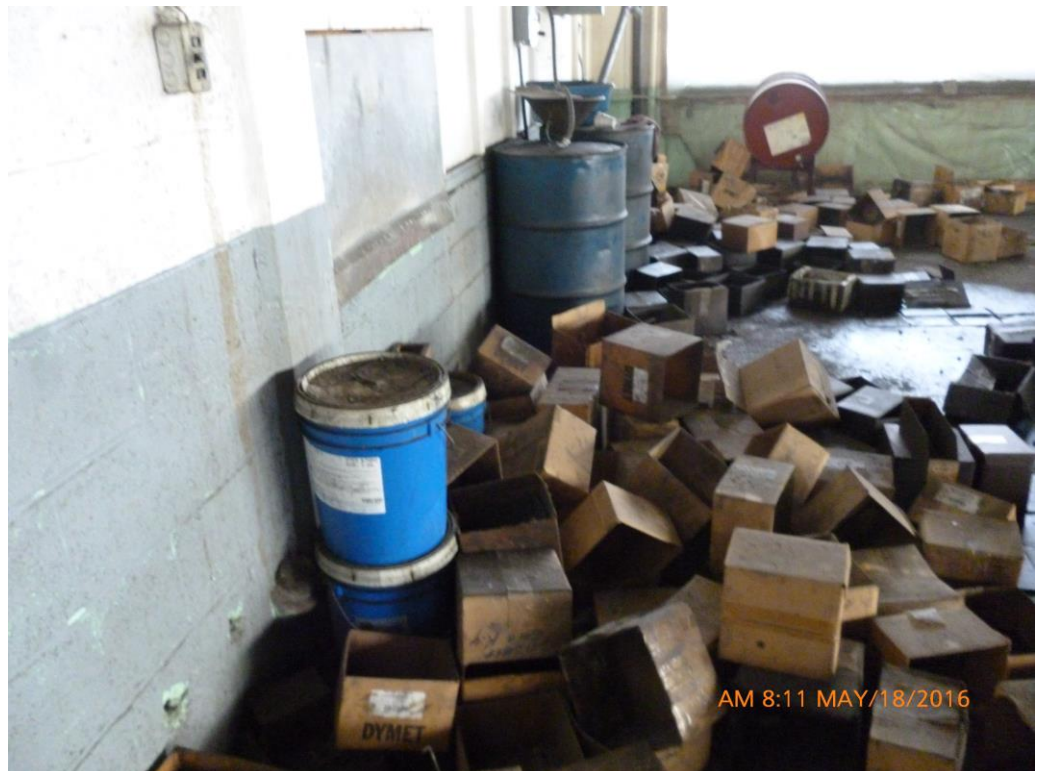
Photograph No.: 36

Typical small container and
drum staging area in the
west building at the Site.
This area has approximately
3 small containers and 3
drums.

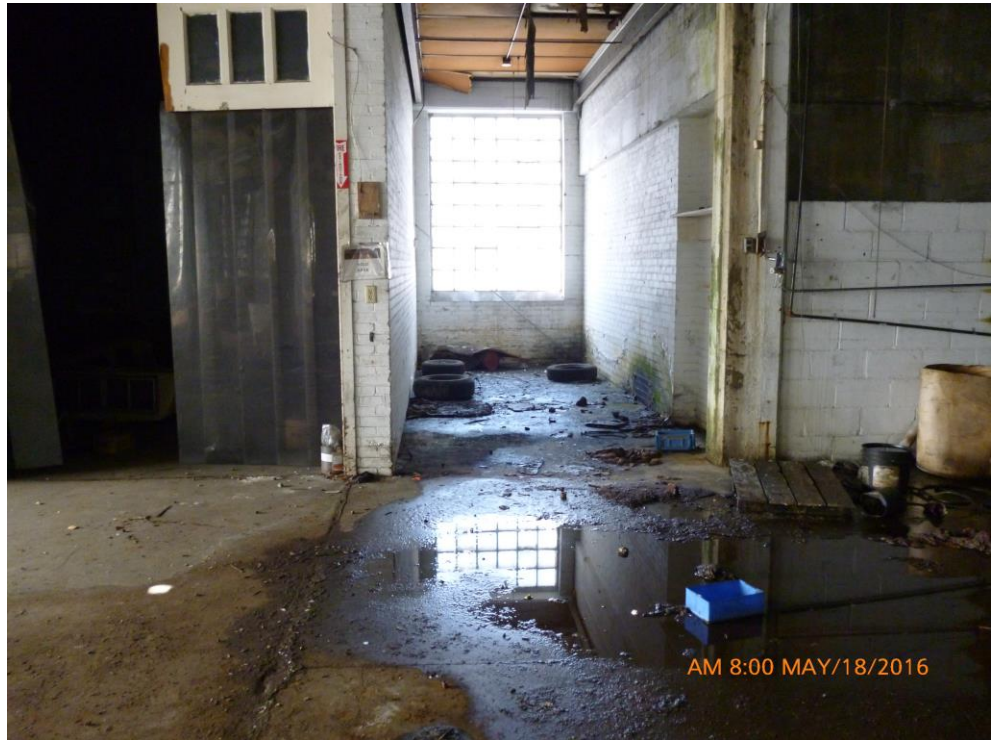
Photograph No.: 41

building (see photograph 41). Some of the windows of the two buildings at the Site were boarded up to cover broken windows. Vandalism through broken windows was noticed during the site reconnaissance. The gaps in the fence and the broken and boarded up windows are considered areas susceptible to potential breaches by trespassers.

Large pool of water near the
south entrance of the west
building. The floor in front
of the window is also wet.

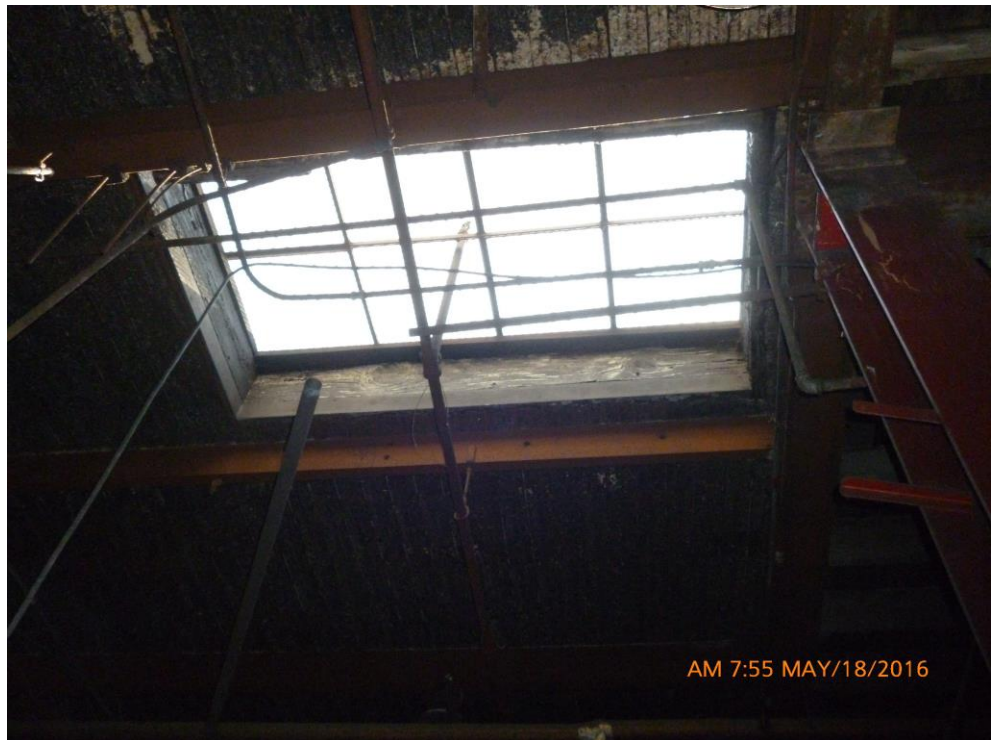
Photograph No.: 42

The Site is comprised of two two-story buildings. The west building had a basement. A fully enclosed gangway connected the two buildings. The Site was fenced in some areas with gaps observed on the east side of the Site. There was a large opening in the roof of the east building (see photograph 42). A large pool of water was observed near the south entrance to the west

Large opening in the roof of
the east building.

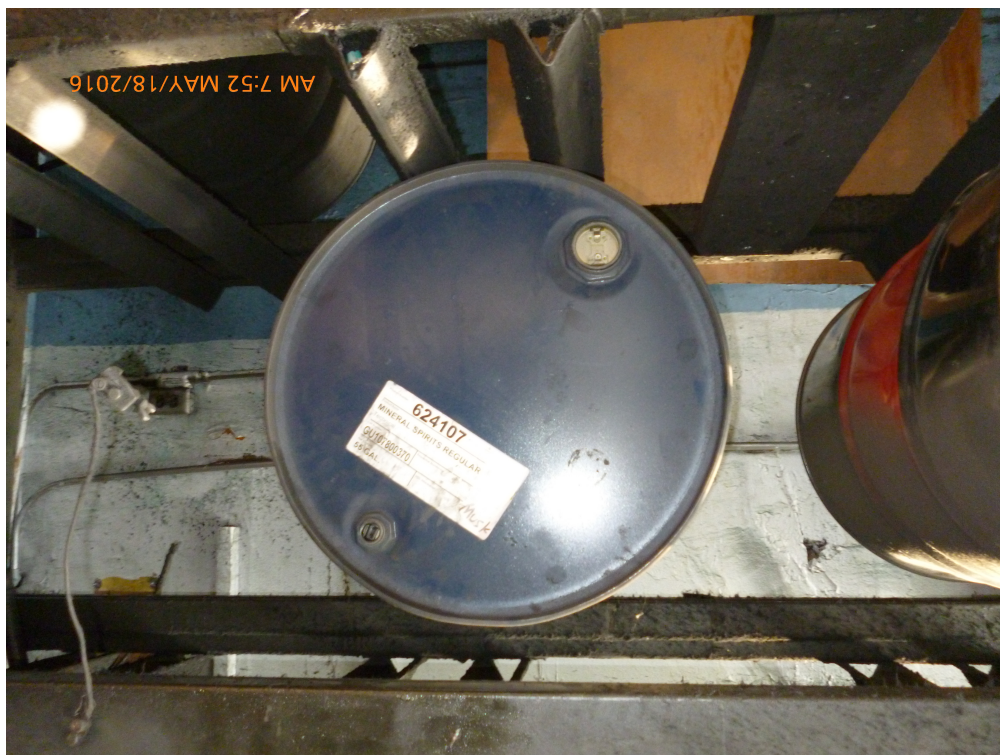
Photograph No.: 43

55-gallon drum labeled
"Regular Mineral Spirits"
located in the southeast
corner of the east building.
